# Manhole Inspection Summary

Manhole # S41UU\_020MH

Insp Date: **2/15/07 1:25 PM**

**Location** Address: **2642 KIRK AVE** Cross Street: **MONTPELIER ST**

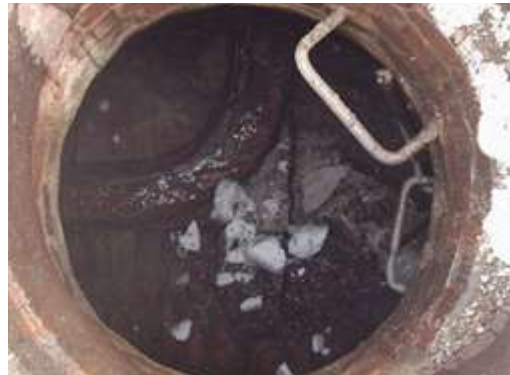
Top View

Bench debris.

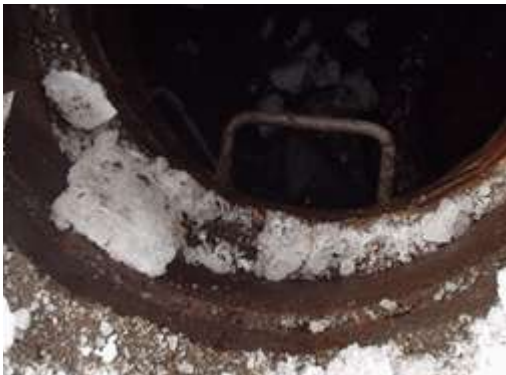
Defect

**Frame** Offset: **2** (in.) Condition: ☐ Sound ☐ Cracked ☒ **Leaks**

**Chimney / Frame Adjustment** ☒ Exists Material: **Brick** ☐ Parged Height: **3** (in.)  
Condition: ☐ Sound ☐ Cracked ☐ Root Intrusion ☐ Loose Brick ☒ **Deteriorated**  
Infiltration: ☐ None ☒ **Joint** ☐ Cracks ☐ Mortar ☐ Roots ☒ **Wall**

Frame leaks. Frame offset. Adjustment infiltration.

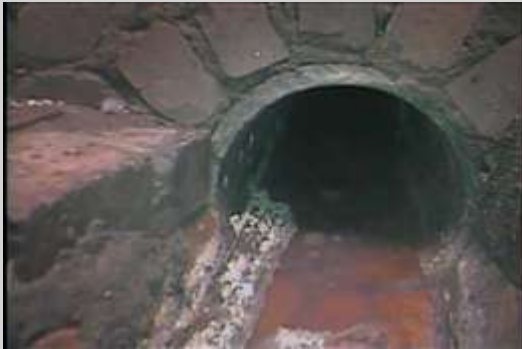
### 8 in. Circular Gravity Sewer Pipe Out @ 12 O'Clock

Deposits: ☐ None ☐ Mud ☐ Sludge ☐ Debris ☒ Grease

Silt Depth: **0** (in.) Deposits Extent: **Light**
